Manhole Inspection Summary

Manhole # S45W__005MH

Location Address: **rear 1536 e clement st**

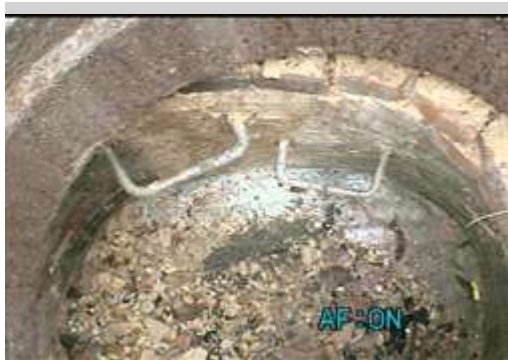
Defect 4

Frame Offset: **2** (in.) Condition: ☒ Sound ☐ Cracked ☐ Leaks

Steps Count: **2** Missing: **0** ☒ **Corroded**

corr steps, frame offset

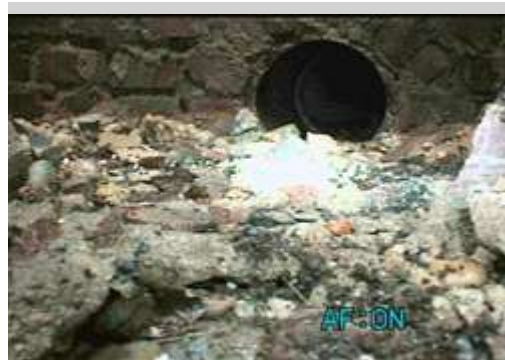
Defect 3

Condition: ☐ Sound ☐ Cracked ☐ Root Intrusion ☐ Deteriorated ☐ Leaks ☒ **Debris**

channel debris

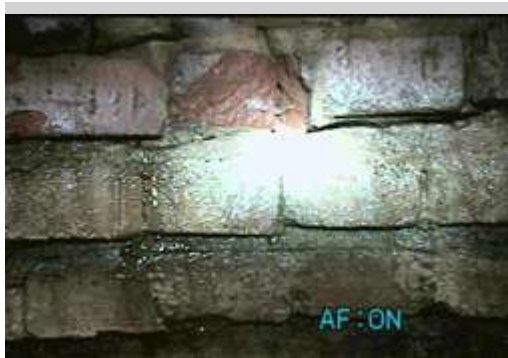
Defect 2

Infiltration: ☐ None ☒ **Joint** ☐ Cracks ☐ Mortar ☐ Roots ☐ Wall

active infiltration from chimney joint

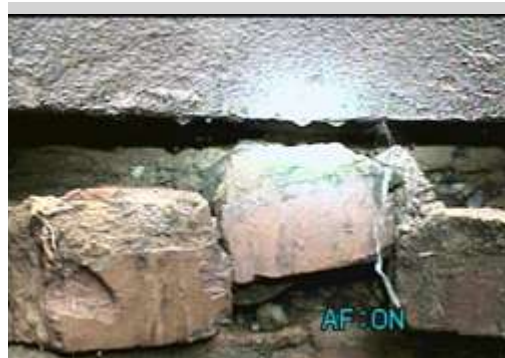
Defect 1

Condition: ☐ Sound ☐ Cracked ☐ Root Intrusion ☒ **Loose Brick** ☒ **Deteriorated**

frame adj loose bricks, deteriorated
